## Oneida Nation Inventory of Contaminated and Brownfield Designated Sites

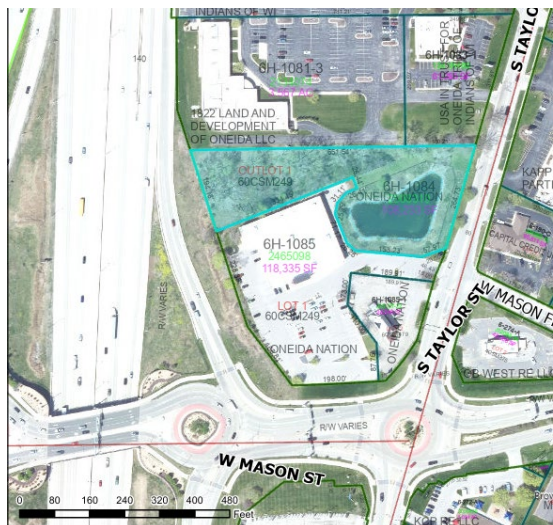
Old Dump Site - Unknown

There were no regulations in place when this landfill was active. The IHS did a study on the Oneida reservation and identified landfills. This is one of those identified but there is no way to know exactly where the landfill is located in this area. Not currently considered a brownfield.

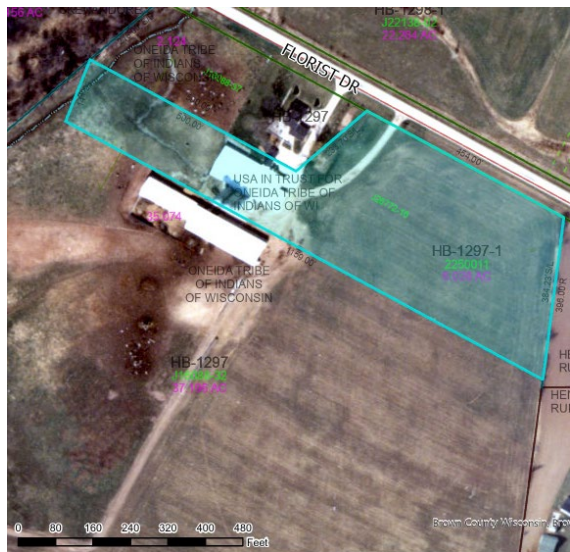
Historical PCB Land Application

Somewhere on this parcel of land PCB sludge was applied. It is unknown where it was applied and it is assumed that the crops that are grown there now are not being contaminated from the toxic material application.

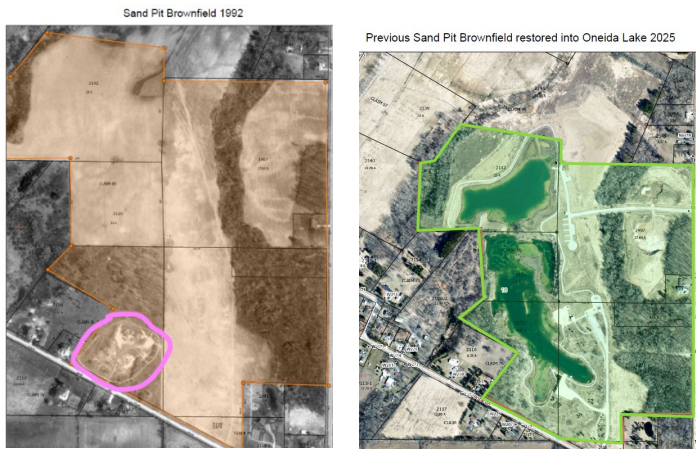
**Previous Sand Quarry Brownfield Restored into Oneida Lake (County Rd U, Oneida)**

The operating quarry was closed, and a nonmetallic mining reclamation plan was created to turn this site into a lake. This site utilized brownfield funding to assess the quarry, and the restoration was funded by NRDA funding.

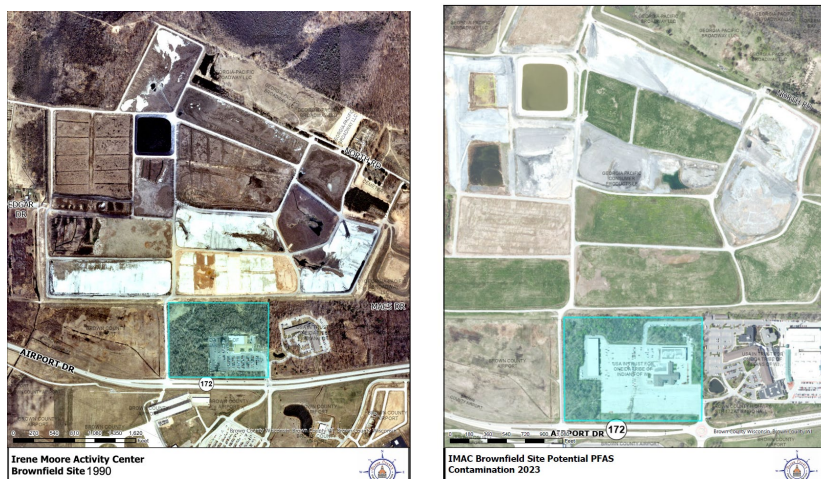
**Irene Moore Activity Center (Bingo Hall) Brownfield Site next to Georgia Pacific Landfill**

Georgia Pacific Landfill was first constructed in 1957, and the Nation was concerned about potential impacts from the paper mill sludge which is high in PFAS (forever chemicals). The Nation attempted to get the site listed as a superfund site. That didn't happen. Georgia Pacific pumps out the water from the wetland and it goes to the waste treatment plant. The sites are currently exceeding PFAS (forever chemicals) levels after water is treated onsite by leachate system. The IMAC became listed as a brownfield site because the Nation will be redeveloping that area. Sampling will be taking place under the current Community Wide Assessment Grant for States and Tribes (CWAGST) grant provided by the U.S. Environmental Protection Agency.

Planned Geoprobe to get down to 25 feet to the groundwater to test for PFAS (forever chemicals) contamination.

Old drinking water well 300 feet deep was tested for PCB's and volatiles, and nothing was found. The well is isolated from other aquifers.

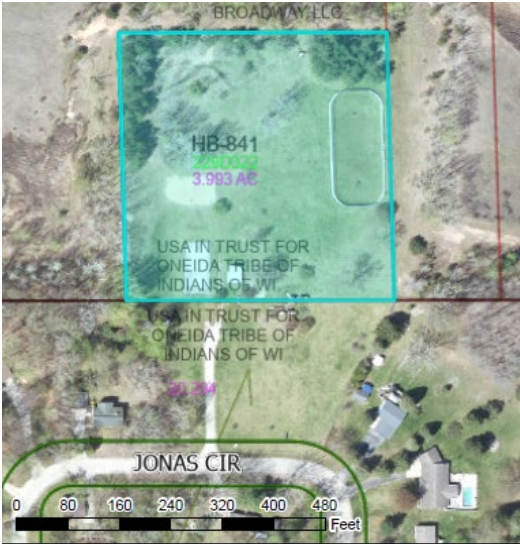
**Jonas Circle Park Potential PFAS Contamination**

Tribal housing development on private water. Concern is there any potential exposure even though the water doesn't flow in this direction. Will be doing further testing for PFAS (forever chemicals) in this area through the CWAGST grant.

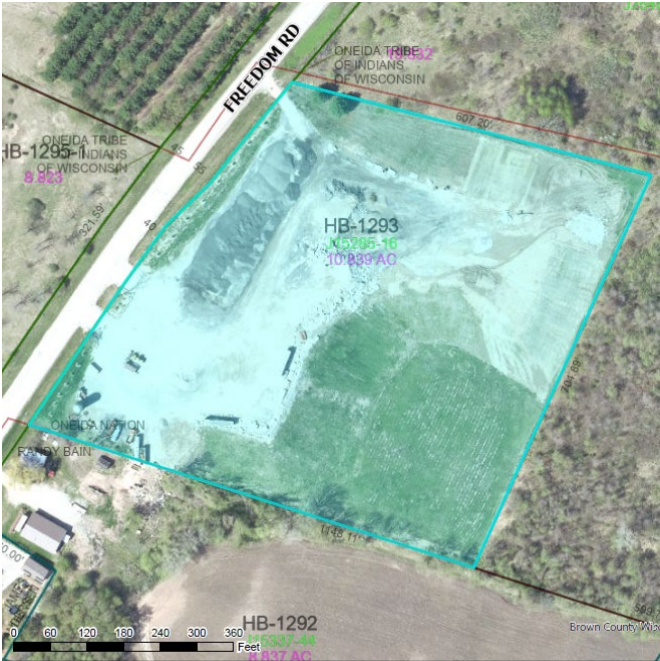
**Roffers I Brownfield Site**

20 acres. 30 feet of rocks, asphalt, rebar, unknown fill. Under the Community Wide Assessment Grant for States and Tribes, geotechnical borings will be completed down to the soil to find out what is present in the 30 feet of fill. Once we figure out what contaminants are present, we can come up with a plan of how to reuse this site.

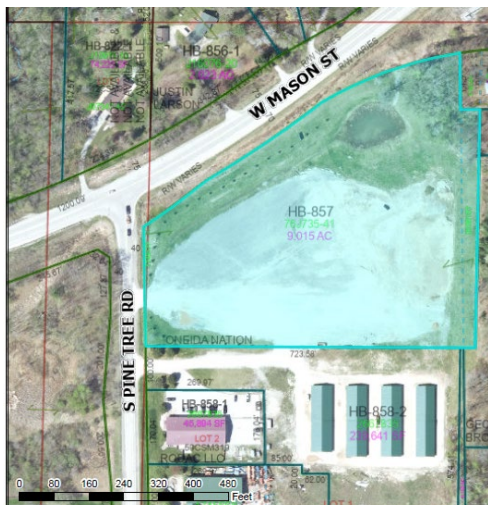
Roffers II Brownfield Site

The Nation purchased in 2024. Used to be a materials staging area. We don't know what kind of fill was here. We are doing a site assessment under CWAGST and will see what the fill material looks like on a profile. When we get to real soil we will find out if there are any real impacts. A lot of gravel was placed. He would get concrete, crush it and put it down. May contain rebar or lead paint. Sometimes asphalt aggregate was added in. Phase II characterization will be completed.

There is an old landfill in the parcel nearby, along with the Georgia Pacific landfill nearby that makes this site eligible for a brownfield determination.

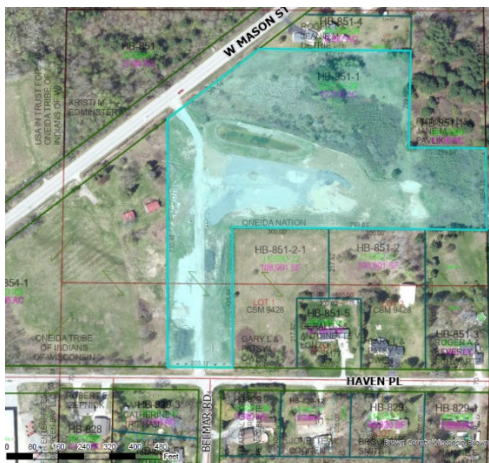
Roffers III Brownfield Site

19-acre parcel. Used to be a materials staging area. We don't know what kind of fill was here. We are doing a site assessment under CWAGST and will see what the fill material looks like on a profile. When we get to real soil we will find out if there are any real impacts. A lot of gravel was placed. He would get concrete, crush it and put it down. May contain rebar or lead paint. Sometimes asphalt aggregate was added in. Phase II characterization will be completed.

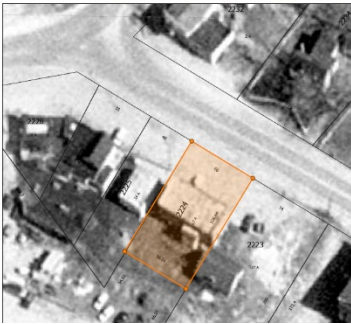
Former Morgans Grocery Brownfield Site 2000

Underground storage tank, heating oil tank and a gas tank. That was demolished. This site will be sampled under GWAGST.

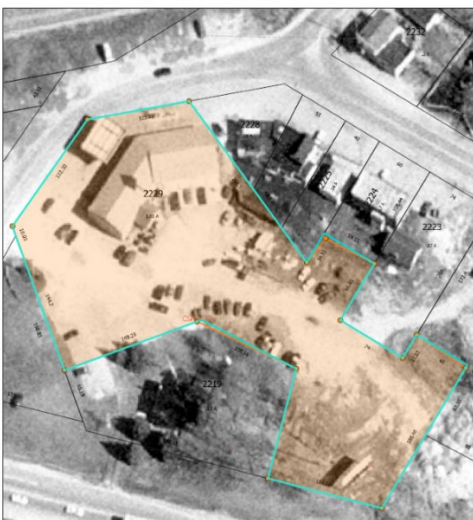
Former Appleton's Gas Station Brownfield Site 2000

Gas station for really long time and behind Appletons was a ravine that was a dump site. Sampling found heavy metals among other toxic materials. Appletons had a tank removed and they found contamination. They did a lust investigation and closed the gas station with residual contamination. Brownfield funding was used to do a Phase I.

More excavation and contamination was removed from behind the gas station.

The bar next to Appleton's gas station also had a gas pump at one time.

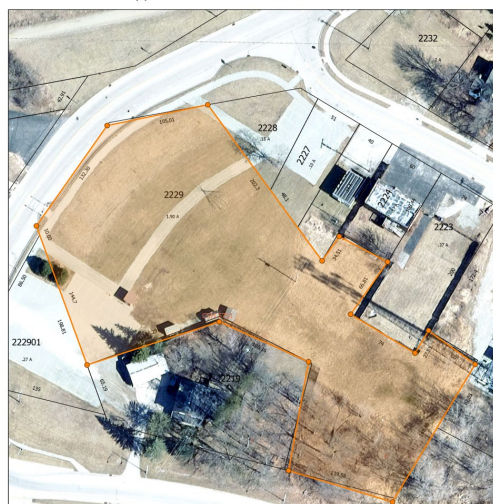
Former Appleton's Service Station Brownfield Site 2025

The site has been restored into the Oneida Farmer's Market site.

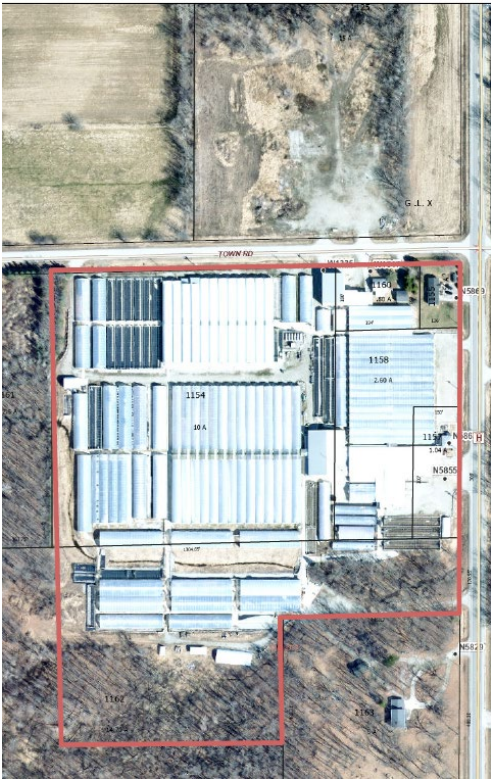
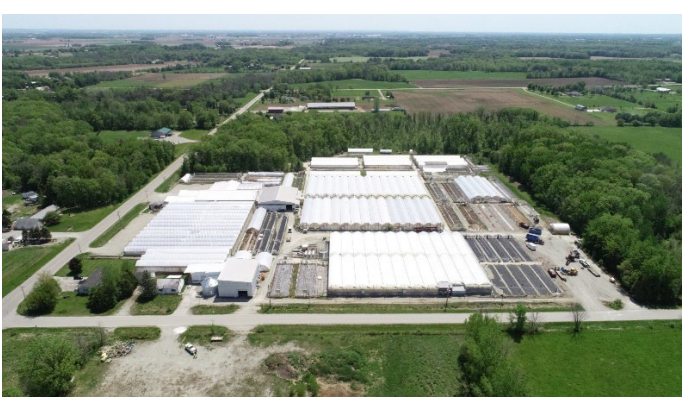
Fox Valley Greenhouse Brownfield Site

Historical greenhouses. Items found were soil sifters, irrigation system, different types of herbicides and pesticides and fungicides were present in testing. Four sumps removed were used to recirculate the water. Elevated levels of arsenic were found. Further testing of sediment from under the sumps was conducted with CWAGST Grant funding.

Hundreds of miles of piping and tile system under the ground that still needs to be removed or addressed. Could be a brownfield that turns into a restoration site due to the interruption of the stream through the corner of the site.
